**“Thank You for Your Support”
OUCH!**

Engineering and the Standard of Care

**E. Mitchell Swann, P.E., LEED AP
Partner and Principal
MDCSystems, LLC®
www.MDCSystems.com**

**24 June 2007
ASHRAE Annual Meeting
Long Beach, CA**

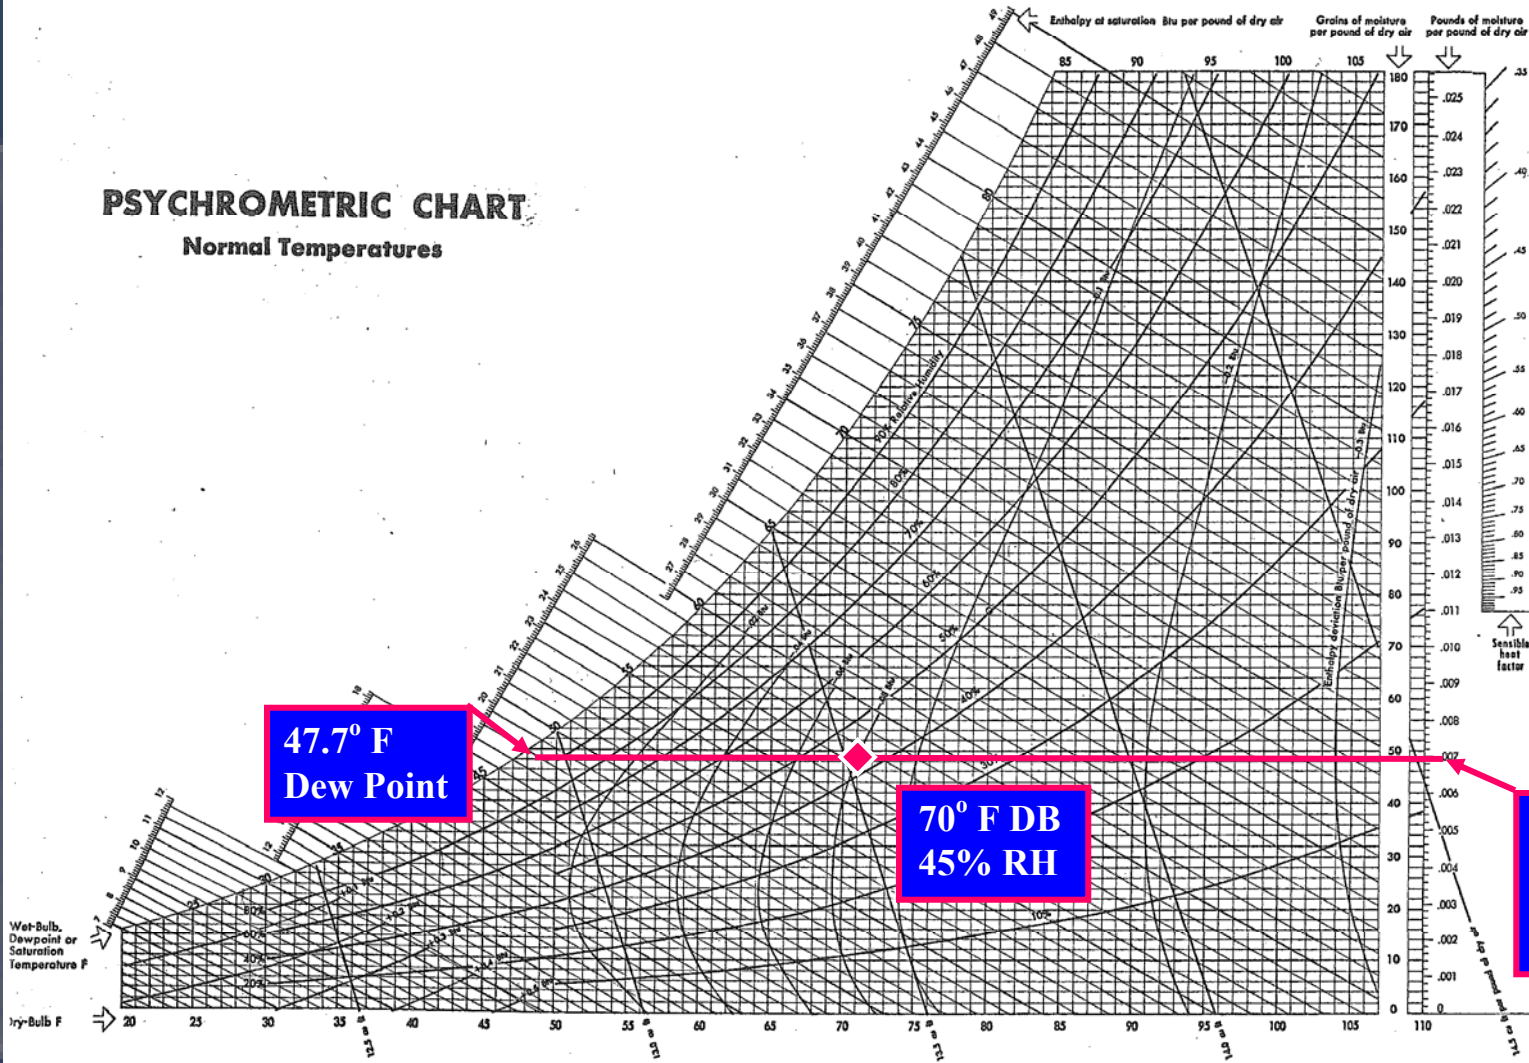
PSYCHROMETRIC CHART Normal Temperatures

Required Room Condition

47.7° F
Dew Point

70° F DB
45% RH

Maximum allowable
moisture per pound
of dry air in order to
maintain required
room condition

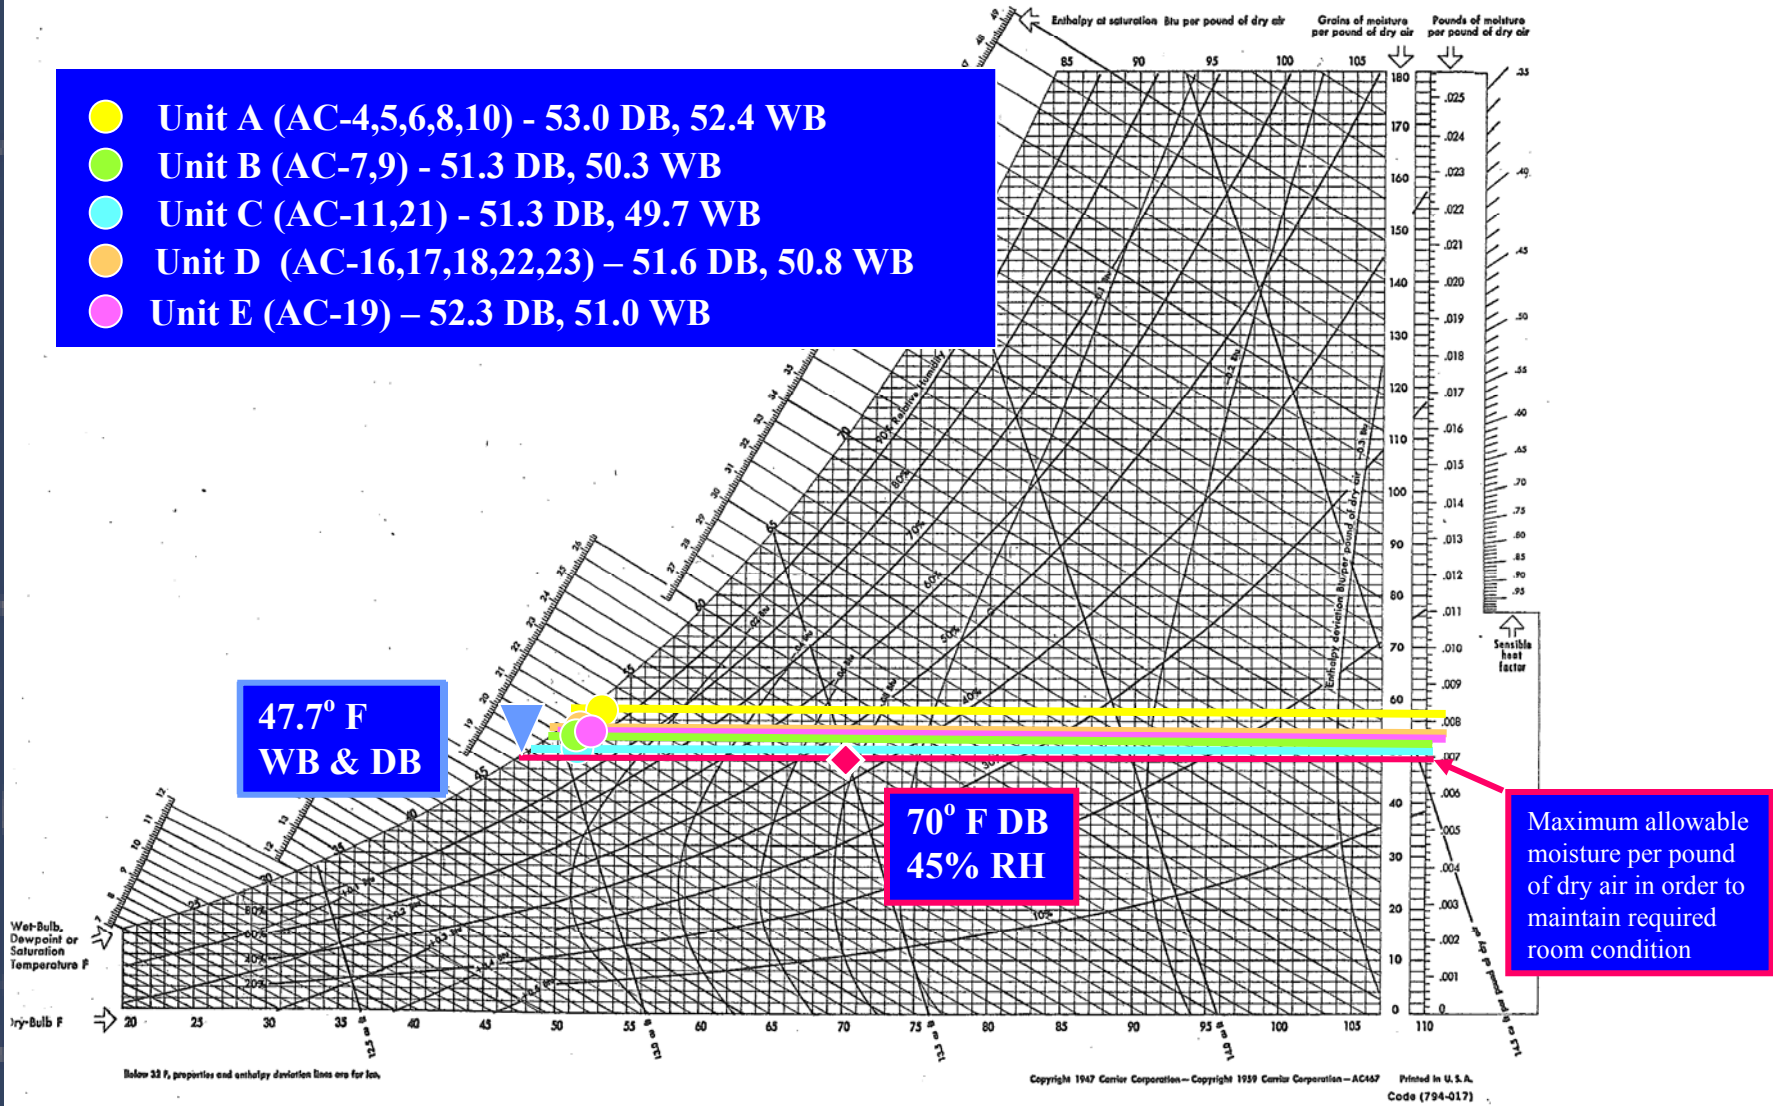
Required Room Condition with Unit LATs

- Unit A (AC-4,5,6,8,10) - 53.0 DB, 52.4 WB
- Unit B (AC-7,9) - 51.3 DB, 50.3 WB
- Unit C (AC-11,21) - 51.3 DB, 49.7 WB
- Unit D (AC-16,17,18,22,23) - 51.6 DB, 50.8 WB
- Unit E (AC-19) - 52.3 DB, 51.0 WB

47.7° F
WB & DB

70° F DB
45% RH

Maximum allowable
moisture per pound
of dry air in order to
maintain required
room condition

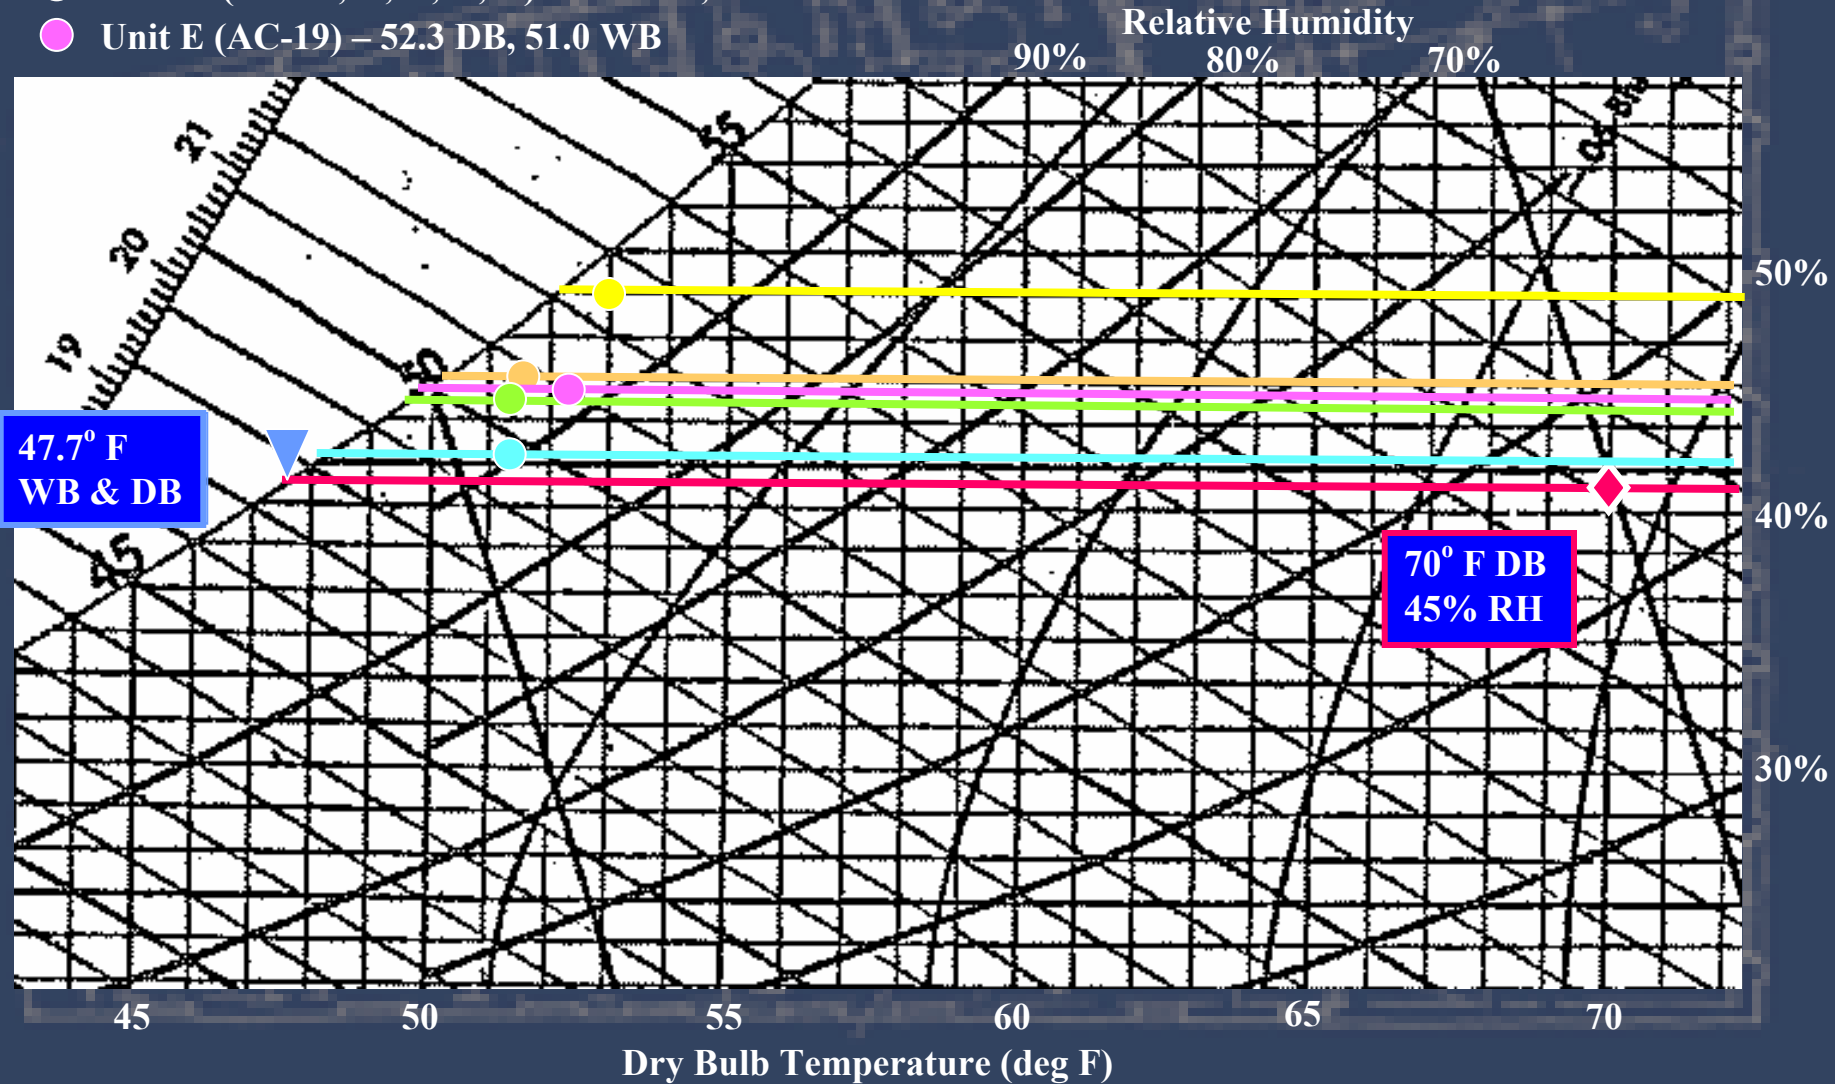
Psychrometric Chart Section with Unit LATs

- Unit A (AC-4,5,6,8,10) - 53.0 DB, 52.4 WB
- Unit B (AC-7,9) - 51.3 DB, 50.3 WB
- Unit C (AC-11,21) - 51.3 DB, 49.7 WB
- Unit D (AC-16,17,18,22,23) - 51.6 DB, 50.8 WB
- Unit E (AC-19) - 52.3 DB, 51.0 WB

◆ Room Condition- 70.0 DB, 45% Max RH
(corresponds to 47.7 Dew Point Temp)

▼ Maximum theoretical leaving air temperature in order to maintain the required room condition
